January 11, 2019

CCR Annual Inspection

Ash Pond

A.B. Brown Generating Station

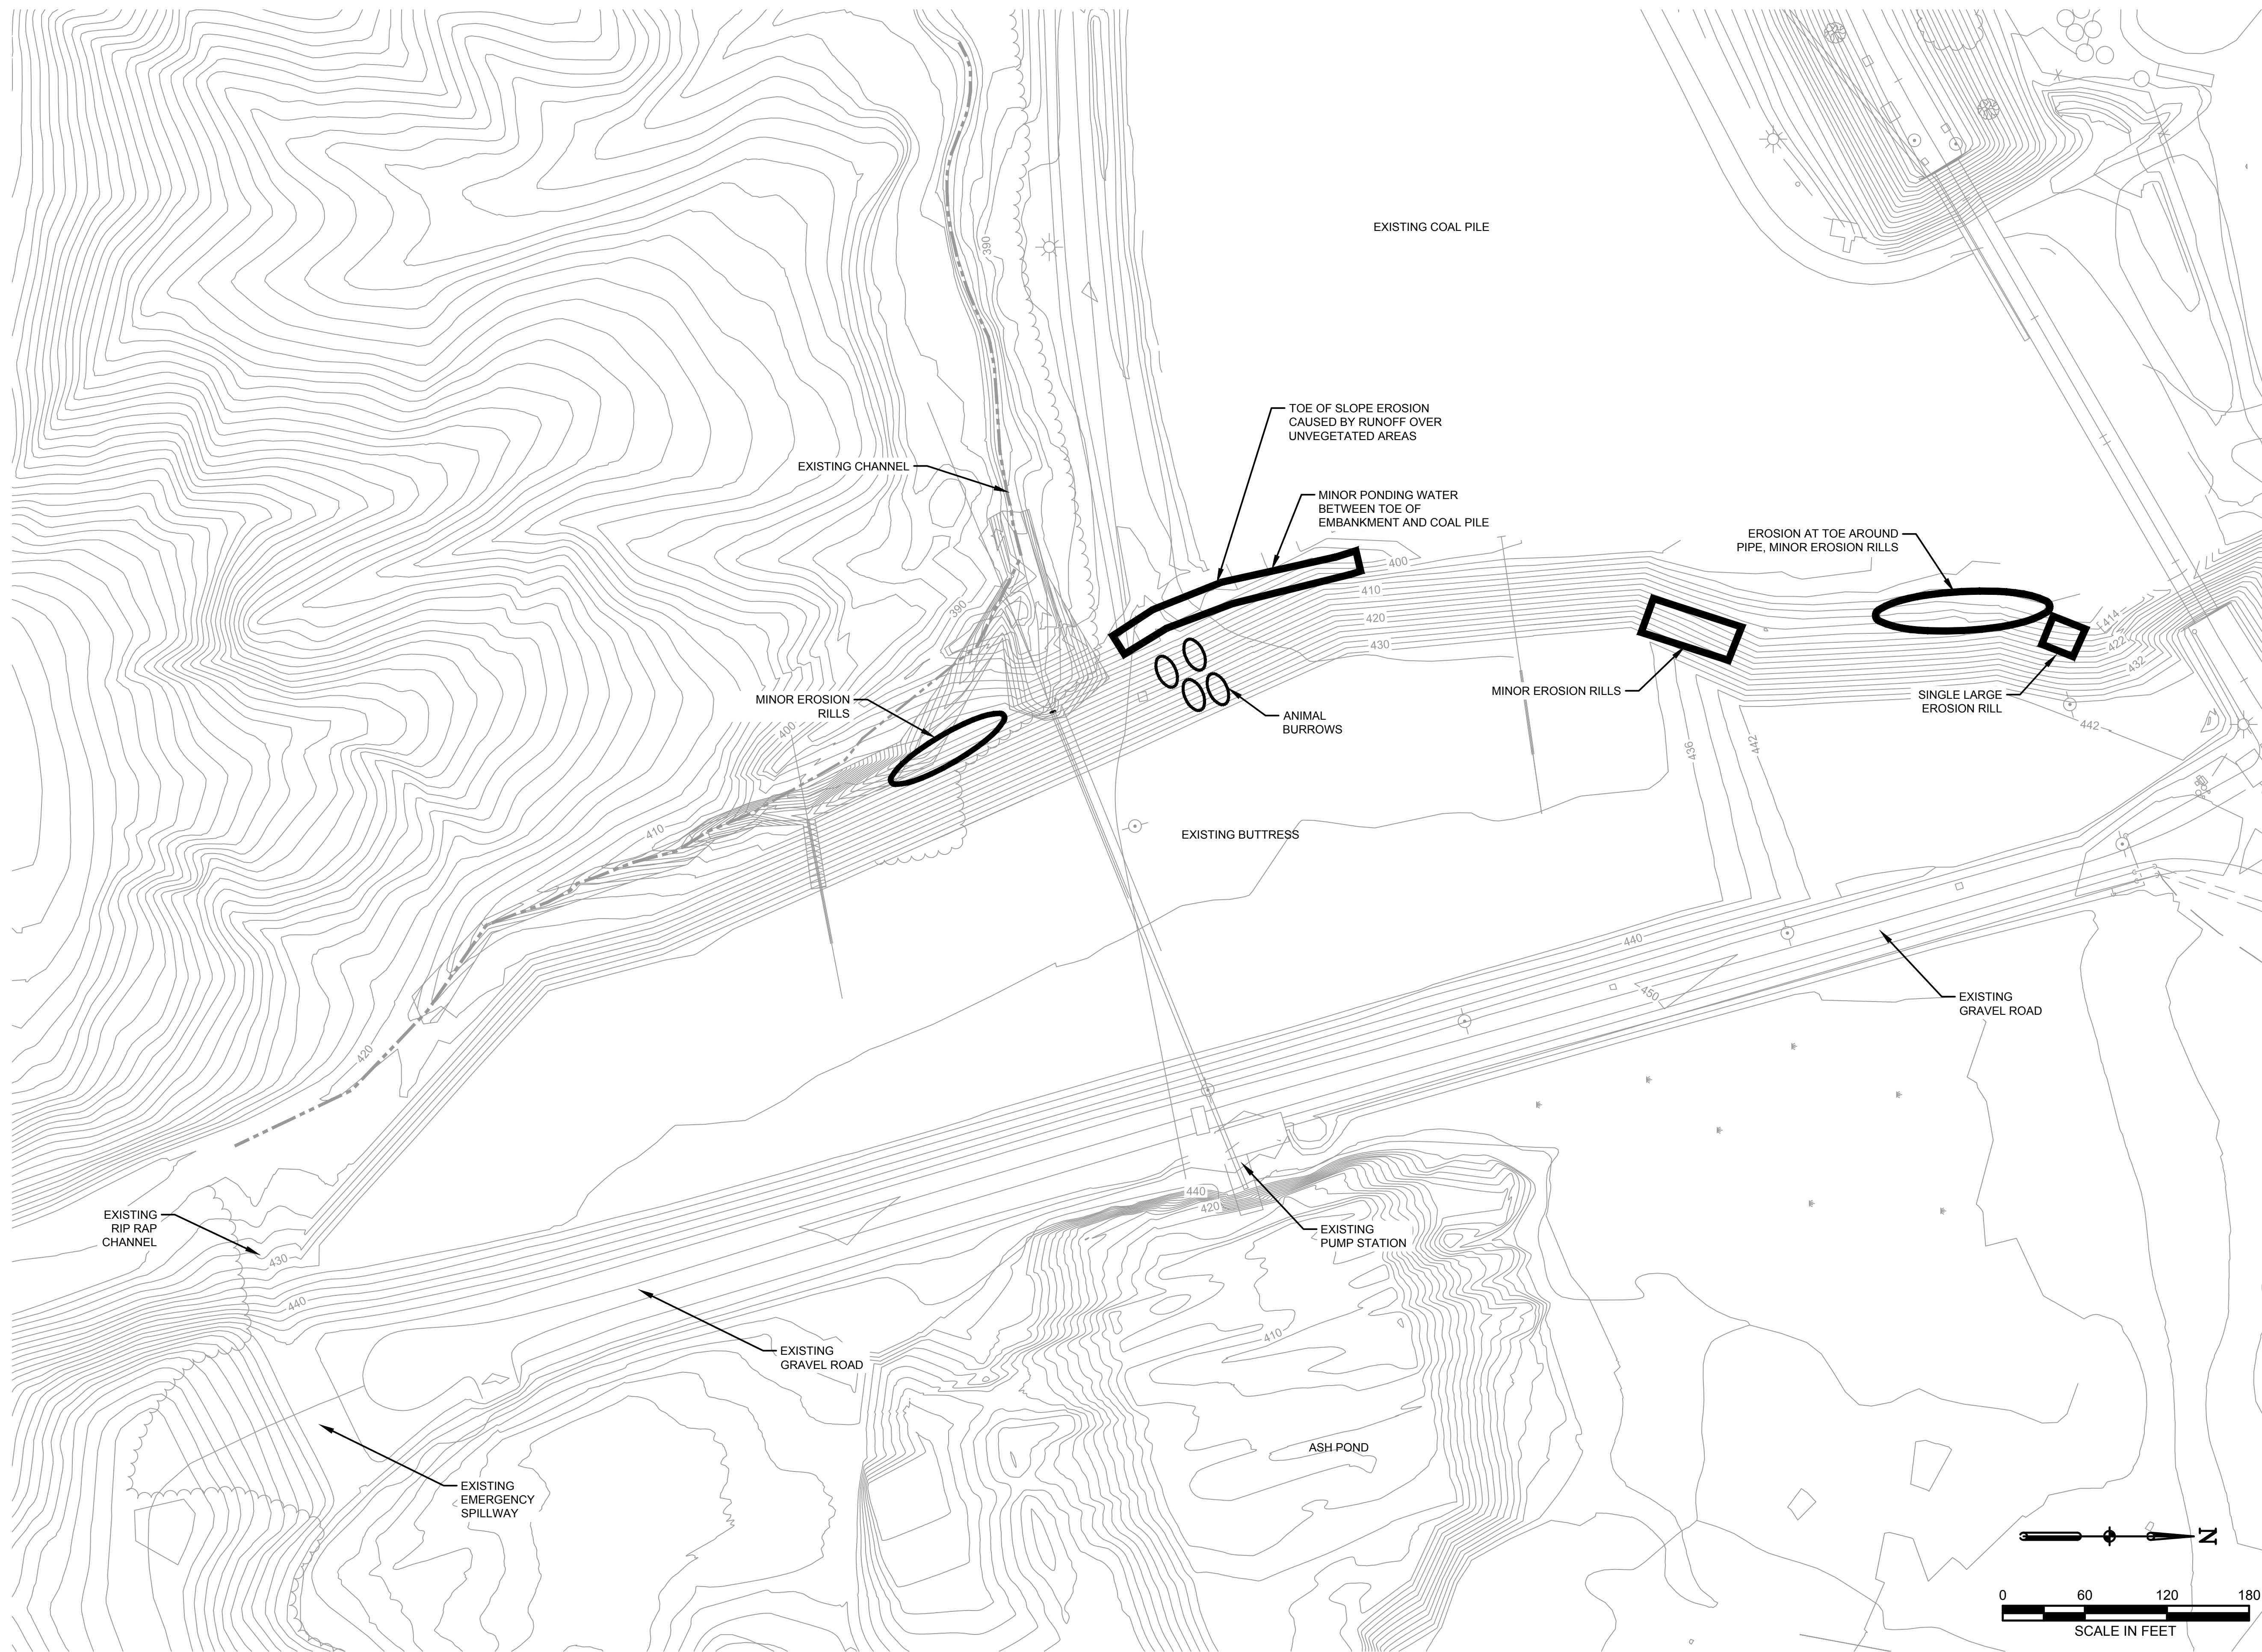
FIGURE 3

Deficiency/Observation	Proposed Corrective Measure
Animal burrows were present at the exterior edge of the buttress along the middle of the outer slope. See attached plan for locations.	Fill with compacted soil and regrade as necessary. Regraded areas shall be seeded with vegetation.
Moderate erosion exists around the end of the surface water diversion outlet pipe at the northern toe of the buttress.	Fill with compacted soil and regrade as necessary.
Sparse vegetation and erosion rills were observed in areas of the buttress's exterior slope. See attached plan for locations.	Reseed and stabilize these areas.
Minor erosion was observed at the toe of the embankment adjacent to the coal pile area. The erosion has caused minor ponding of water between the toe of embankment and the coal pile.	Regrade and reseed eroded areas. Continue to maintain positive drainage along the swale towards the outfall.
