VISUAL SITE INSPECTION REPORT - 2015

**SOUTHERN INDIANA GAS AND ELECTRIC
A. B. BROWN GENERATING STATION
TYPE III RESTRICTED WASTE LANDFILL
WEST FRANKLIN, IN**

ATC PROJECT NO. 170LF00159

January 14, 2016

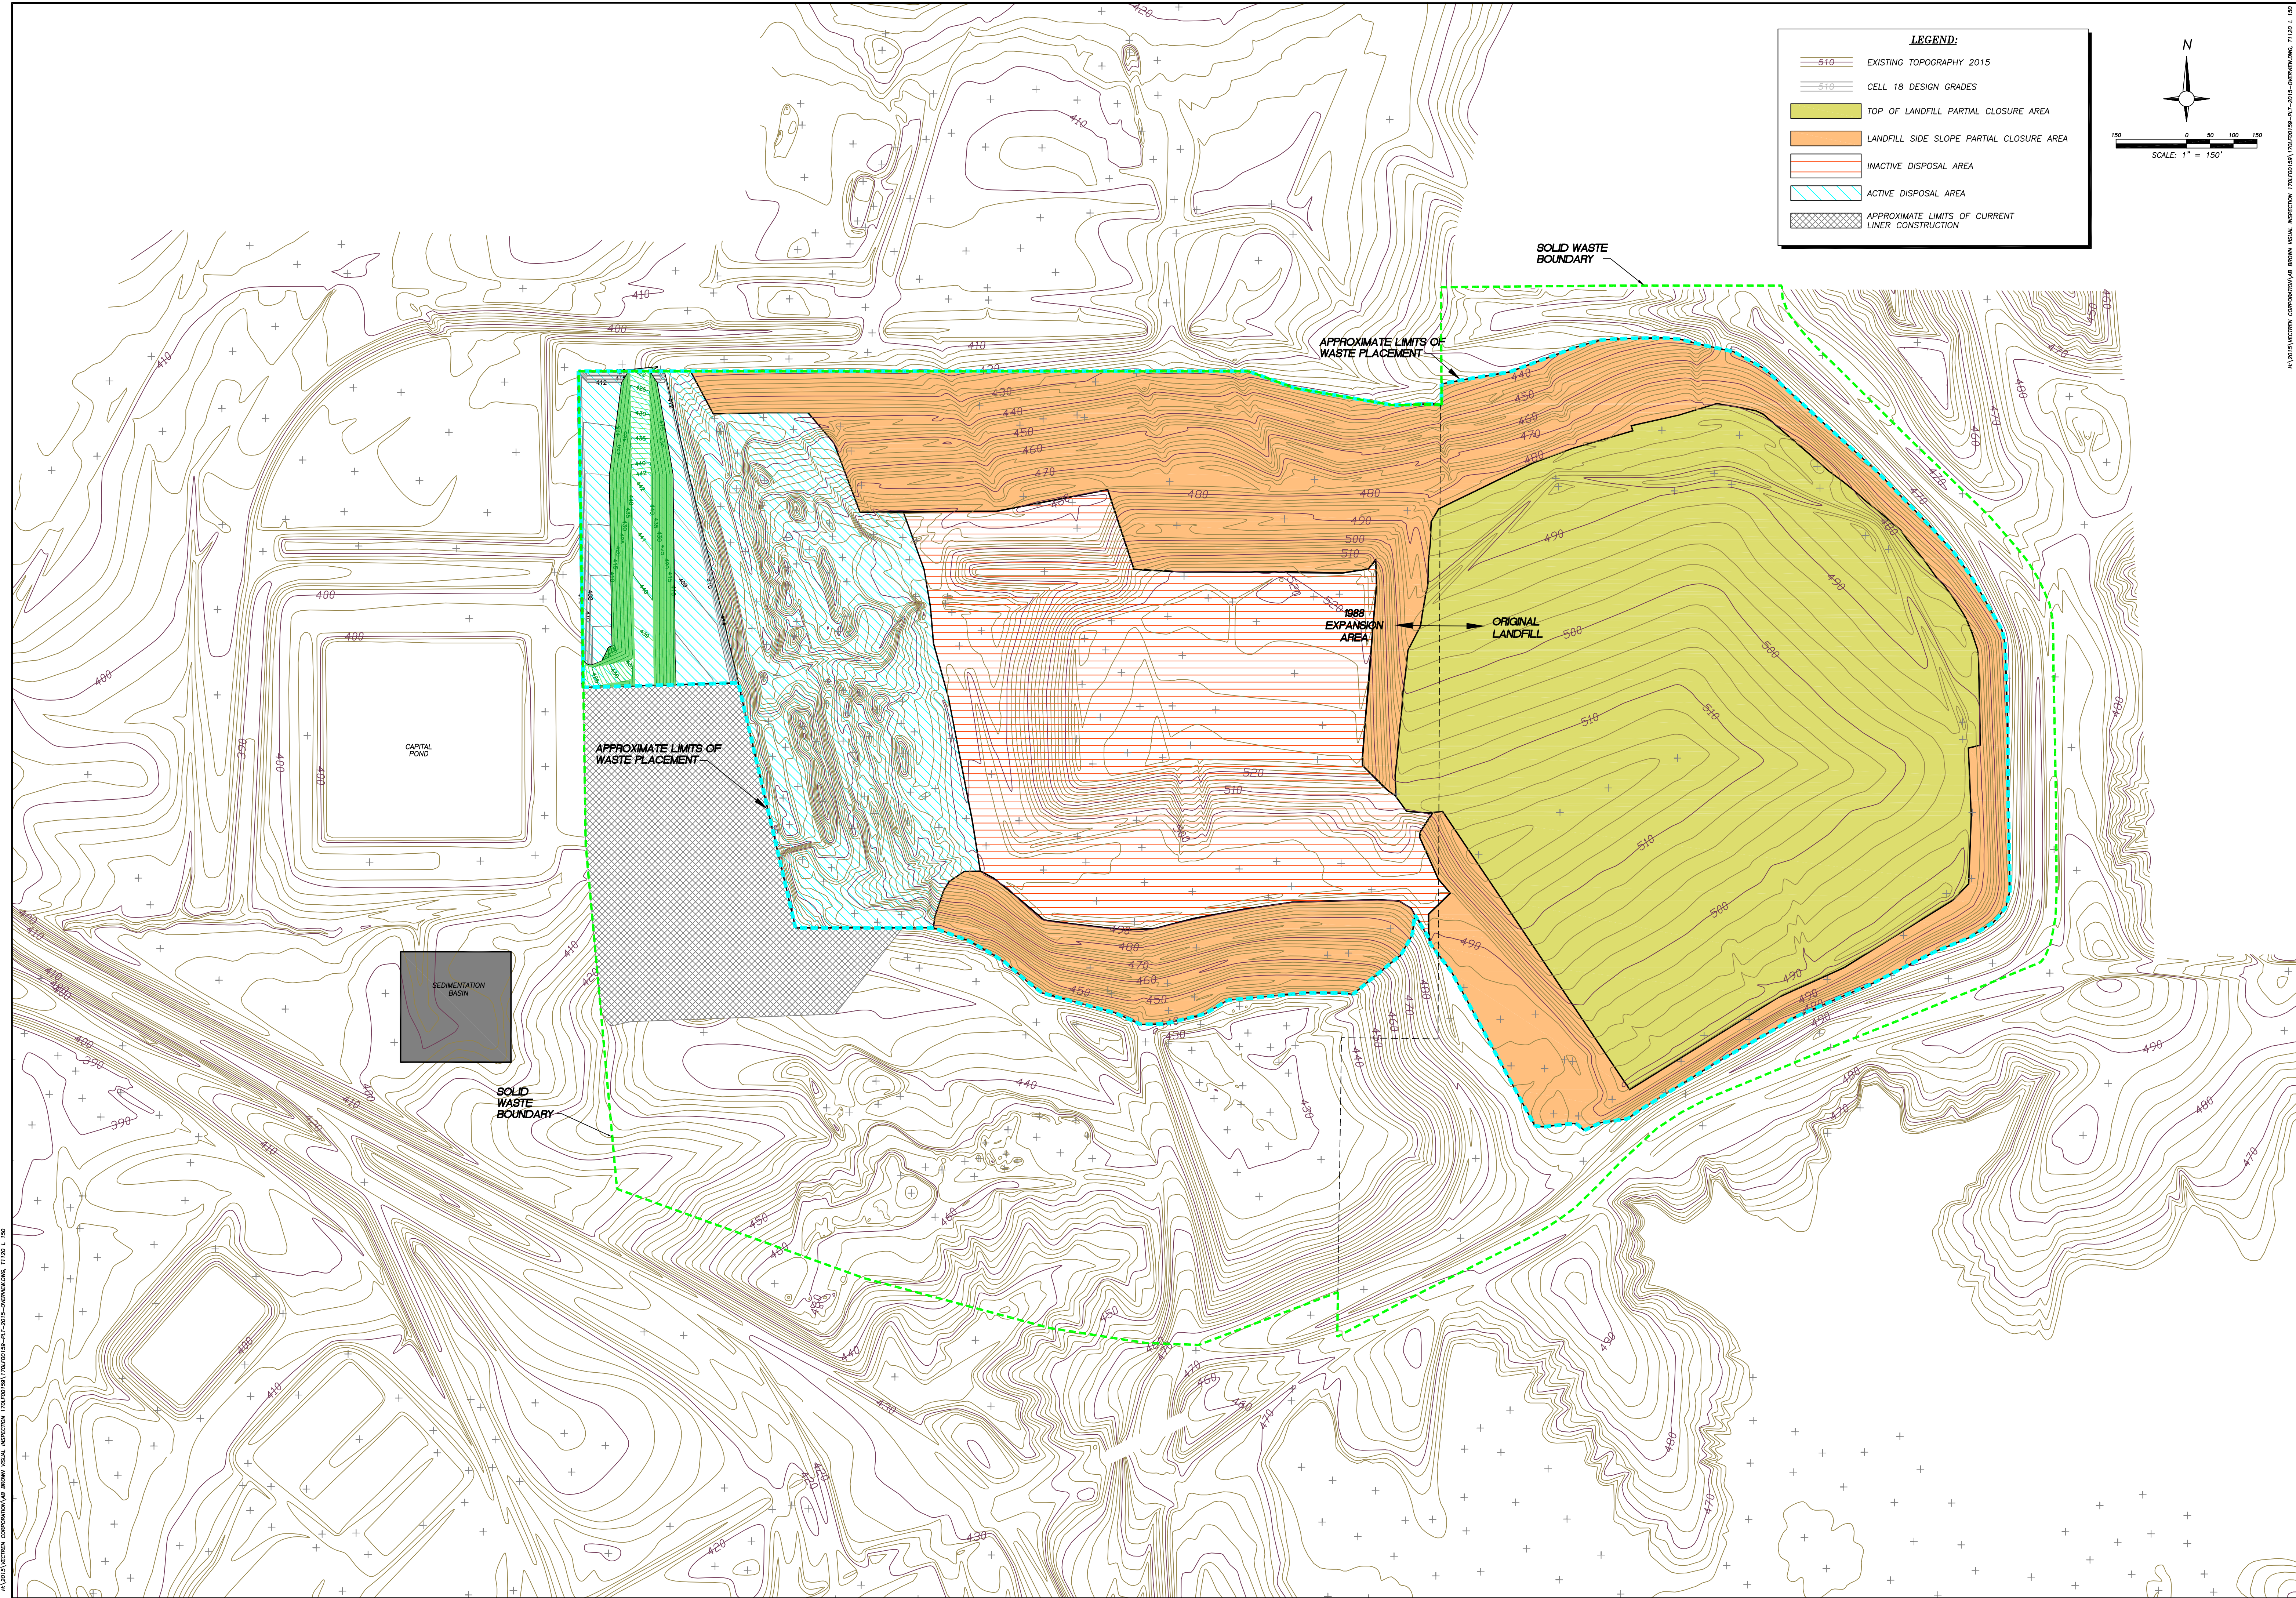
APPENDIX A: SITE PLAN

The approximate limits of each of these areas is noted on Sheet 1 in Appendix A. The following paragraphs include a summary of the observations made during the inspection followed by our recommendations in bold print.

The final cover on the perimeter slopes noted on Sheet 1 in Appendix A consists of a minimum of 24 inches of cohesive soils, covered with 0.5 ft of topsoil. The approximate limits of the 24.5 acre closed portion of the slopes is noted on Sheet 1 in Appendix A. Documentation of the completion of the closure activities along these slopes was submitted to IDEM in 2015. Items noted during the visual inspection of this area are described in the following list.

The inactive disposal area noted on Sheet 1 in Appendix B generally consists of approximately 18 acres across the top of the central portion of the landfill. This area has not yet been filled to the approved final grades, although it has been covered with an intermediate soil cover and vegetated until filtercake placement resumes. Items noted during the visual inspection of this area are described in the following list.
